Surface Examination Report

Field File **ML-44446** L.S.

May 16, 1995

DOGM # M/045/028

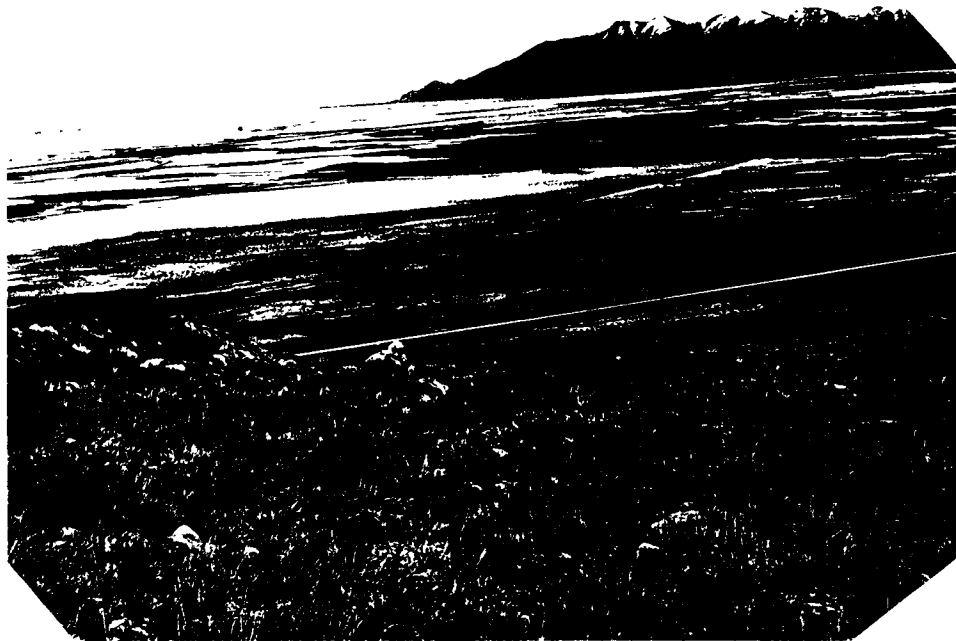
Photo # 2, Looking east along north section line of Section 36. Land on right side of dashed line is in Section 36. Land on left side of dashed line is in Section 25. The northeast section corner of Section 36 is out of sight, beyond the crest of the hill. The road in the background is the access road to the Chemical Lime plant.

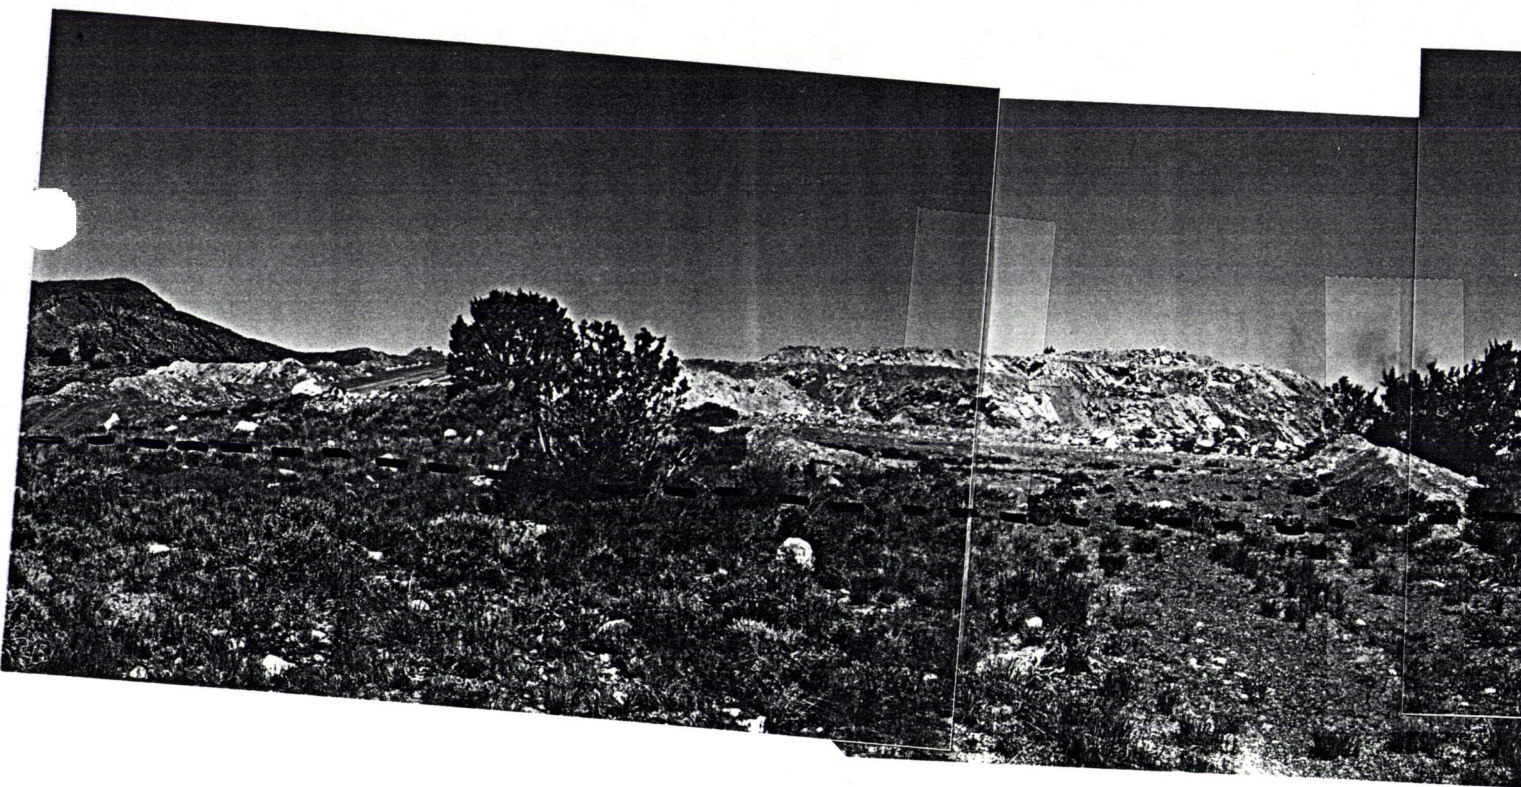
Photo # 3, Looking north from existing road in Section 36 onto position of the north boundary line of Section 36. The arrow shows disturbance has taken place on Section 36.

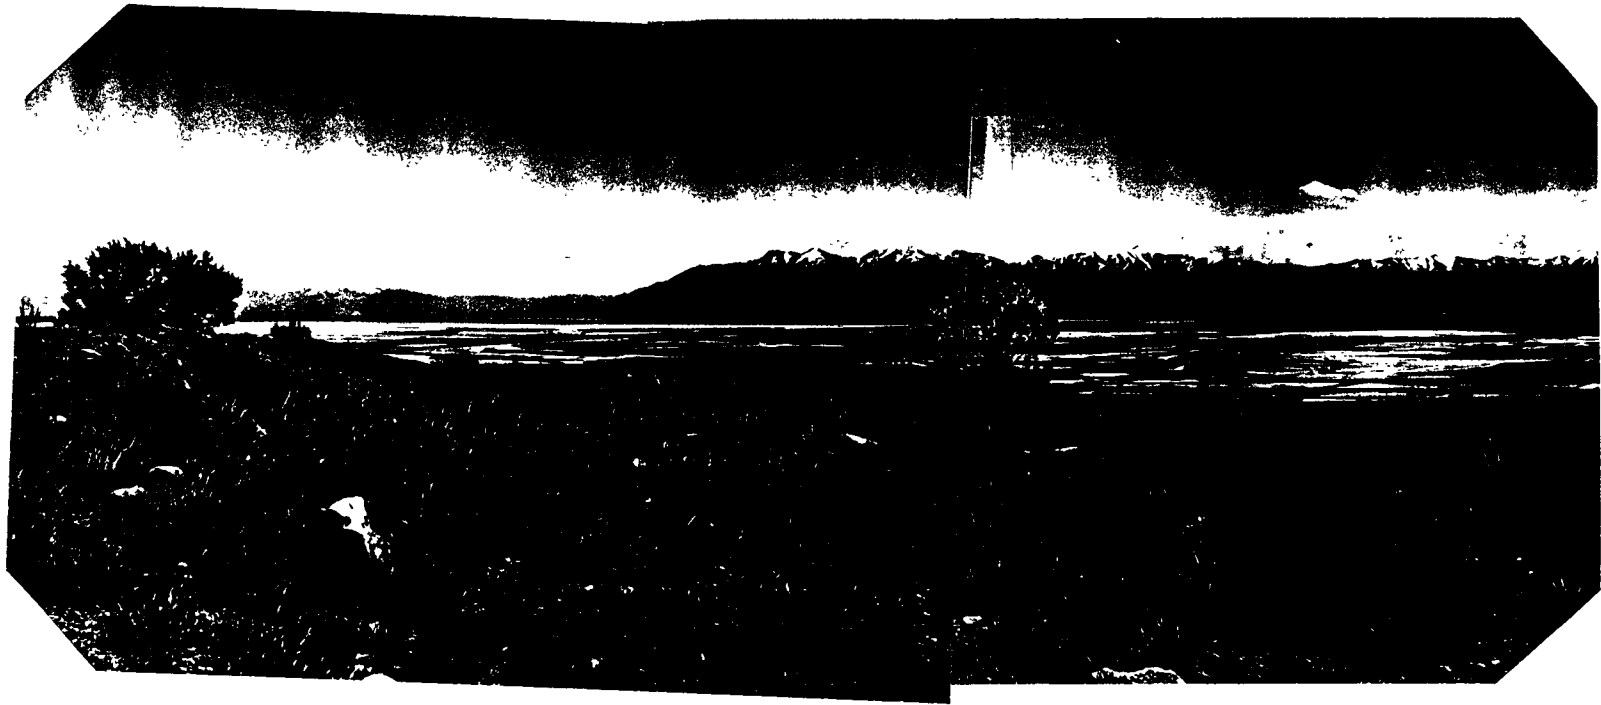
Photo # 4, Looking east along north section line of Section 36 from near the existing road that is depicted on the accompanying map. Note nearest surface disturbance on left side of photograph.

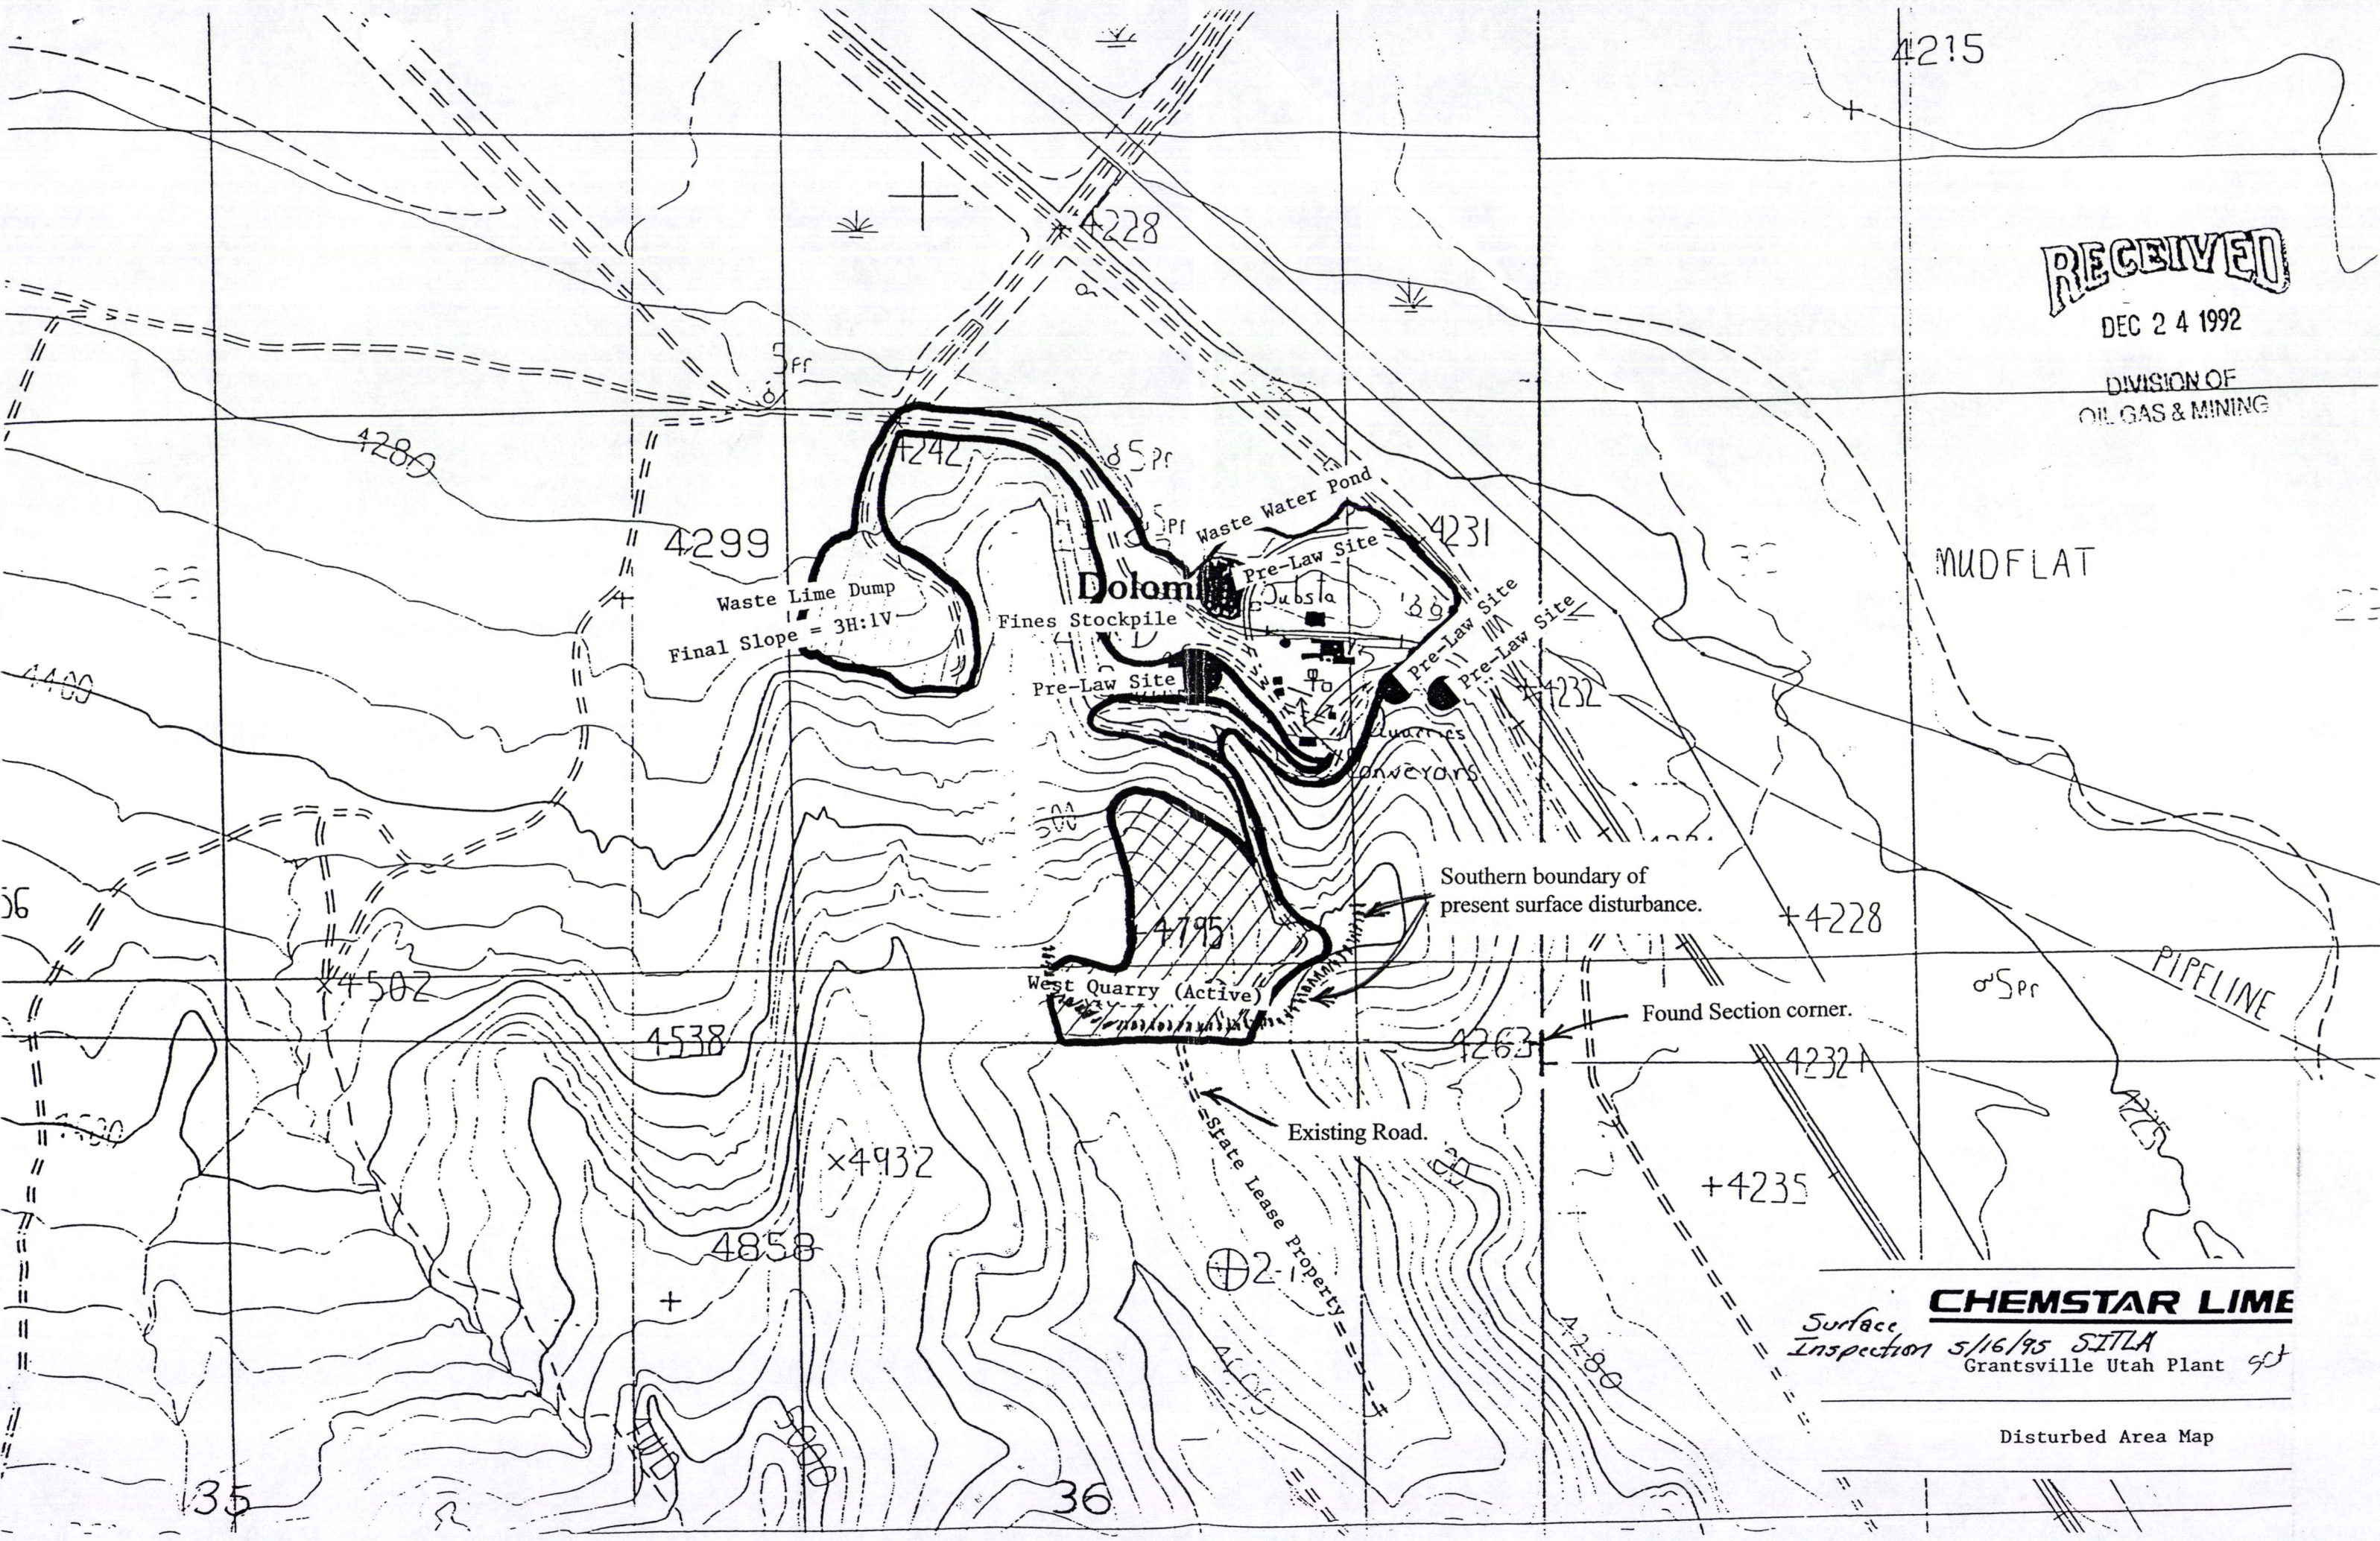
Disturbed Area Map

The accompanying map which was provided by Chemical Lime and apparently produced by Chemstar Lime does not accurately show the exact location of surface disturbance and mining that is presently being conducted on Section 25, just north of Section 36. A more accurate outline of surface disturbance in the S1/2 S1/2 of Section 25 is depicted in red on the accompanying map. At the time of this inspection mining operations were being conducted on a hill in the S1/2S1/2 of Section 25 that is identified on the accompanying map at Bench Mark elevation point 4795. The North boundary line of Section 36 is approximately 30 feet south of any surface disturbance that has been created by Chemical Lime's mining operations. The only disturbance of any kind on the leased lands is what appears to be infrequent use of a preexisting road that traverses the hill top in the NE1/4 of Section 36. This road is shown on the accompanying map.
